ILLINOIS ENVIRONMENTAL PROTECTION AGENCY MEMORANDUM

SUBJECT: LPC #1198010003 – Madison County

Hartford/Chemetco

On December 15, 2010, a site visit was conducted at Chemetco, Inc. I met with Jorge Garcia, ES&H Manager for the Estate of Chemetco and Mr. Michael Murray, Supervisor for AIS.

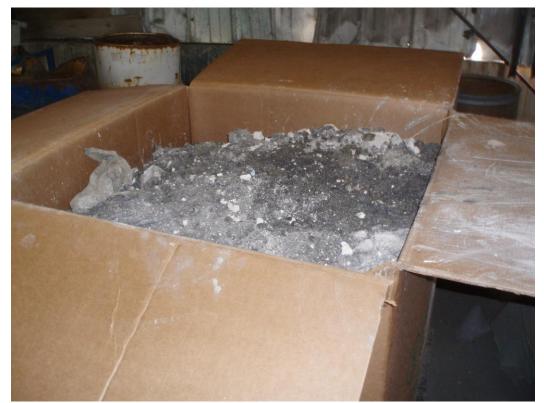
The material that was taken from the Foundry to the Fines Building was placed in four cardboard boxes. The boxes were being moved to the Receiving Building during the site visit. One box in the Receiving Building is shown in the attached photos #001, #002, and #003. The second box on the forklift outside of the Receiving Building is shown in attached photo #004. The remaining two boxes in the Fines Building are shown in the attached photo #007. These boxes will be relocated to the Receiving Building by the end of the day.

Photo by: M. Cozadd Exposure #: 001 Comments: One of four cardboard boxes of material from Foundry that was taken to Fines Building and is currently in Receiving Building.

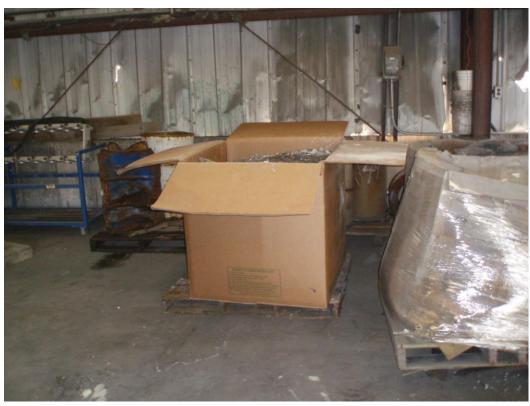
Photo by: M. Cozadd Exposure #: 002 Comments: One of four cardboard boxes of material from Foundry that was taken to Fines Building and is currently in Receiving Building.

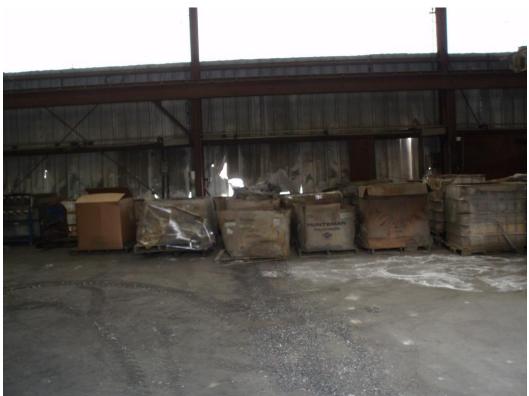
Photo by: M. Cozadd Exposure #: 003 Comments: Material in Receiving Building.

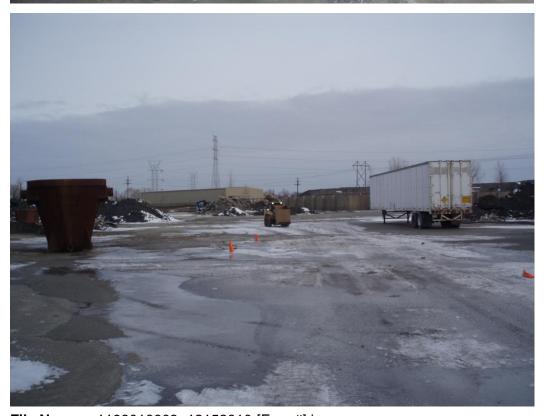
Photo by: M. Cozadd Exposure #: 004 Comments: Second of four cardboard boxes of material from Foundry that was taken to Fines Building and is currently being taken by forklift to the Receiving Building.

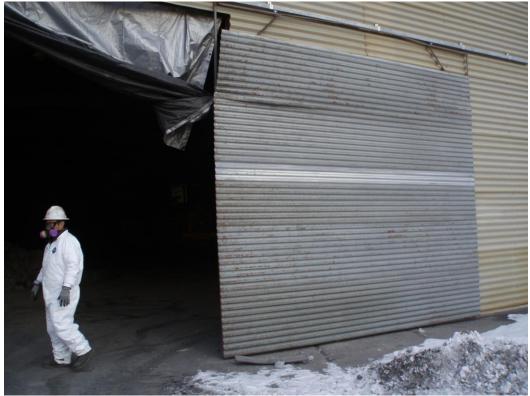
Photo by: M. Cozadd Exposure #: 005 Comments: Door on Fines Building.

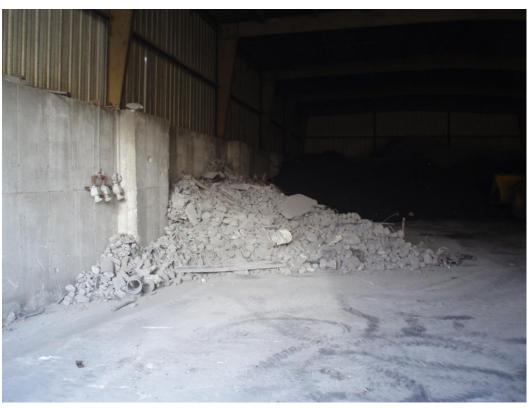
The door on the Fines Building is shown in the attached photo #005. The attached photo #006 shows the segregated broken concrete, damaged dimensional lumber, and other miscellaneous wastes from screening operations in the Fines Building. This pile is in the process of being shipped off-site as a hazardous waste for cadmium (D006) and lead (D008).

Photo by: M. Cozadd Exposure #: 006

Comments: Segregated

broken concrete, damaged dimensional lumber, and other miscellaneous wastes from screening operations in Fines

Building.

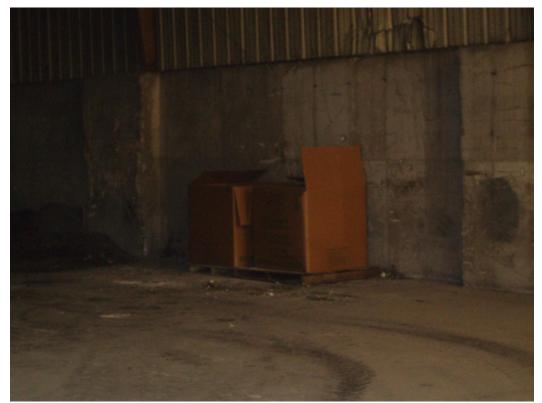
Photo by: M. Cozadd Exposure #: 007 Comments: Last two of four cardboard boxes of material from Foundry that was taken to Fines Building. Material to be

relocated to the Receiving Building.

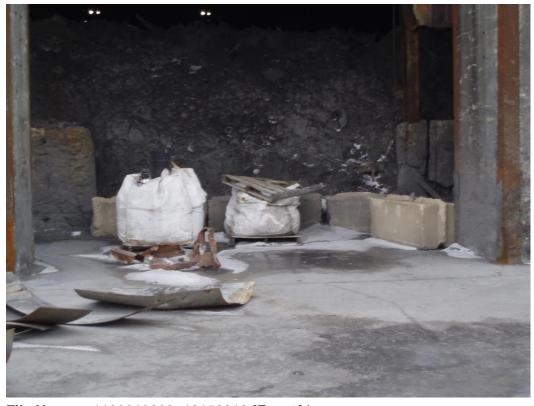
Two super sacs of spent sand from decontamination procedures was staged for removal in the Dome Building (see attached photo #008). Piles of scrap metal to be decontaminated are shown in the attached photos #008, #009, and #010.

Photo by: M. Cozadd Exposure #: 008 Comments: Two super sacs of spent sand from decontamination procedures staged in Dome Building for removal off-site.

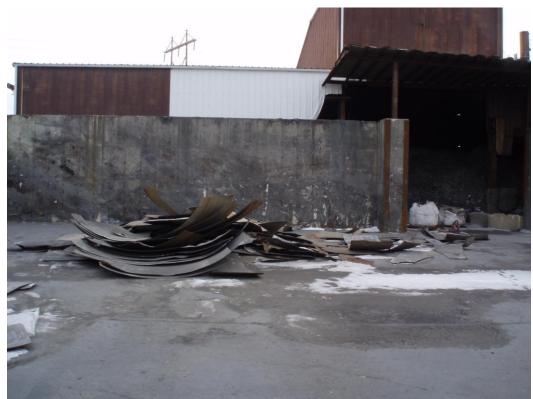
Photo by: M. Cozadd Exposure #: 009

Comments: Scrap metal

staged inside Dome Building for

Building for decontamination.

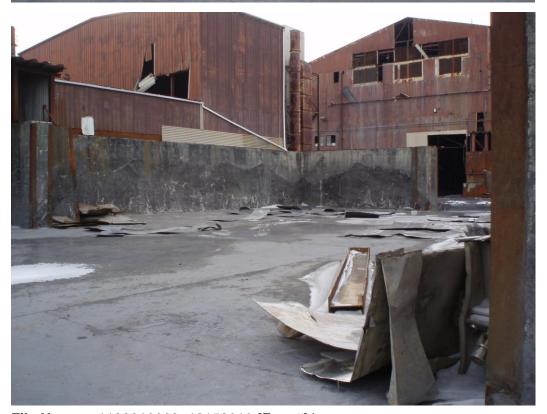
Photo by: M. Cozadd Exposure #: 010 Comments: Scrap metal staged inside Dome Building for decontamination.

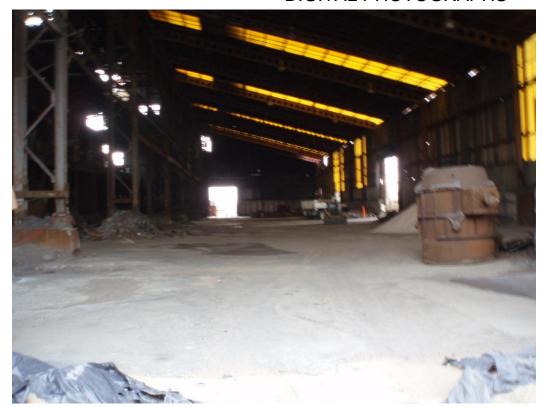
Photo by: M. Cozadd Exposure #: 011 Comments: Interior of Foundry as seen from

north doorway.

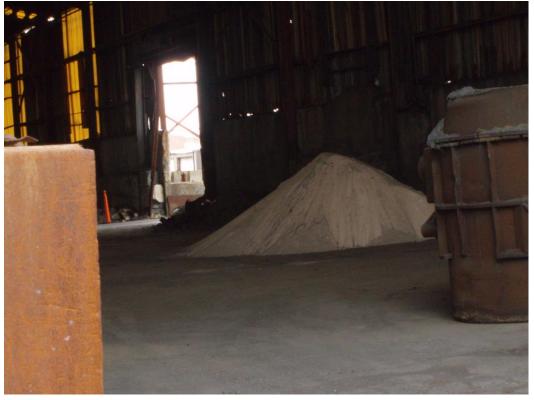
The attached photo #011 is the interior of the foundry as seen from the north doorway. The pile of silica sand shown in the attached photo #012 was moved to the Foundry about one and half weeks ago.

seen from north

Photo by: M. Cozadd Exposure #: 012 Comments: Pile of silica sand in Foundry as

doorway.

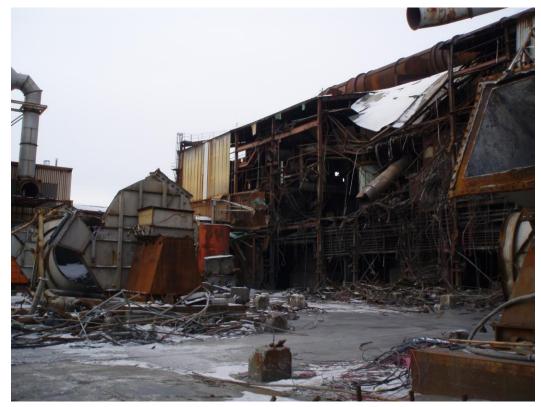
Photo by: M. Cozadd Exposure #: 013 Comments: Demolition

in AAF area.

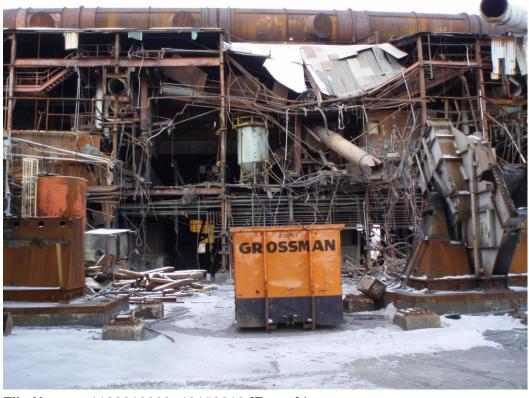
Photo by: M. Cozadd Exposure #: 014 Comments: Demolition

in AAF area.

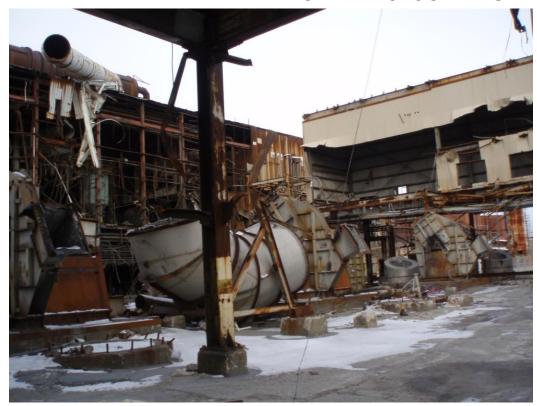
Exposure #: 015
Comments: Demolition

in AAF area.

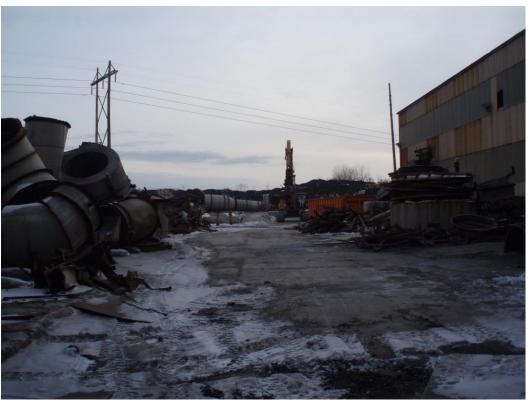
Photo by: M. Cozadd Exposure #: 016 Comments: Scrap metal staged near Tank Building from demolition

in AAF area.

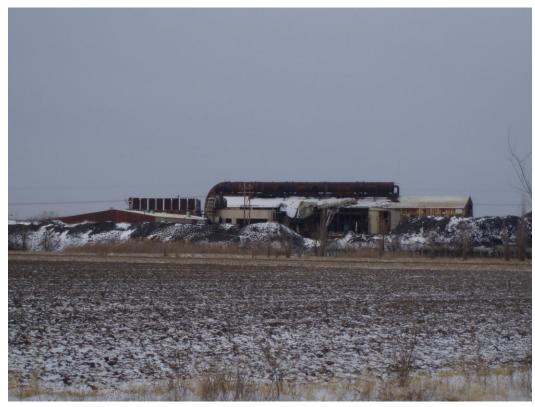
Photo by: M. Cozadd Exposure #: 017

Comments: Overview of

site.
